## OTHER NON-SOLVED NC ACROSS THE LHC RING AND POTENTIAL IMPACT ON PERFORMANCES

V. Baglin, CERN, Geneva, Switzerland

During Run 1, several non-conformities across the ring with impact on machine performances were identified and planned to be solved during the long shutdown 1 (LS1). During this long shutdown, new non conformities were also produced and / or identified. In this talk, some of these non-conformities are presented and discussed together with their impact on machine operation, technical stops and LS2.

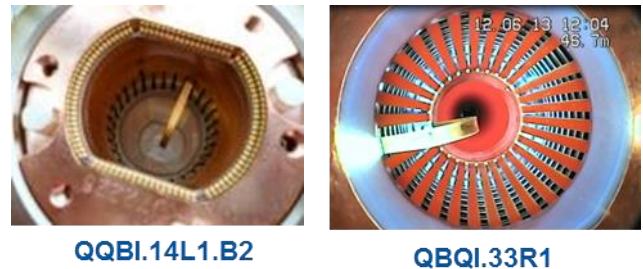
One of the most critical equipment of the cryogenic vacuum system is the plug-in-module, PIM. These components are non-conform since the installation of the LHC. The first non-conform PIM was found by chance at QQBI.26.R7 in August 2007 after the warm up of sector 78. The origin of this NC has been traced back to a NC during manufacturing which was not properly documented and followed-up. Two bending angles of the RF fingers of the PIMs are out of tolerances which, as a consequence, might lead to buckling during warm up. In particular, the QQBI type PIM (interconnect quadrupole-dipole) are the most critical. A systematic check is therefore mandatory once the PIM temperature is higher than 120-130 K. Possible means of checks are RF ball test, tomography, x-ray and endoscopy. Moreover, a systematic repair of the PIM is done when magnets are consolidated [1]. For LS1, in parallel to the arc repair, the PIMs located at the arc extremity: QQBI.7R and QBQI.8L were consolidated. Today, after LS1, 13 % of the PIMs are consolidated *i.e.* 456 out of 3443. All RF-ball tests were ok before cool down. As shown in

Figure 1, after the arc warm up, 2 PIMs were found buckled: in the arc 81 and the arc 12. It must be noted that the arc 12 was already warmed up in 2009. Therefore, systematic check of the PIM is needed even if an arc was already warmed up.

Figure 1: The tow PIMs which were founded buckled following the LHC arcs warm up after Run 1.

For LS2, if the consolidation strategy remains unchanged; no significant impact of this NC is expected. However, it must be remembered that, any warm up above 120-130 K during technical stop, (E)YETS or long shutdown will requires inspection to ensure proper operation of the LHC.

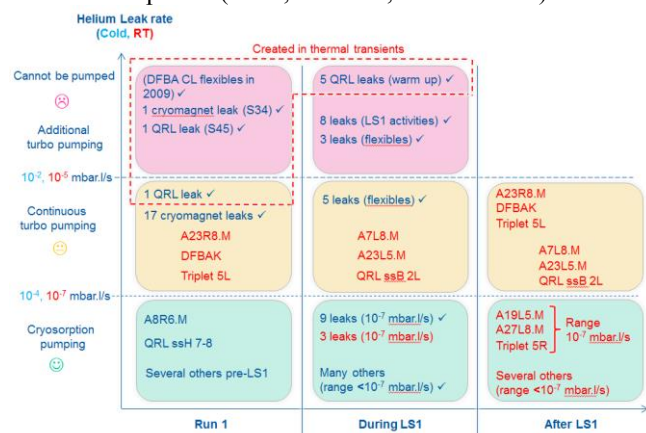
As shown in Figure 2, the machine operated during Run 1 with several leaks above  $10^{-5}$  mbar.l/s. Such large leak level required the use of additional turbo pumping. After LS1, most of the leaks are in the range  $10^{-8}$  -  $10^{-7}$  mbar.l/s which can be managed by simple cryosorption pumping. Only 6 leaks are in the range  $10^{-7}$  -  $10^{-5}$  mbar.l/s but can still be managed by the fixed turbomolecular pumping system. It is worth underlying that several leaks ( $>10^{-7}$  mbar.l/s) were created during LS1 due to collateral damage. Fortunately, these leaks could have been repaired. To this date, the vacuum insulation system behaves as expected.

Figure 2: Time classification of leaks observed in the vacuum insulation system

During technical stops or long shutdown, any thermal transient occurring during quench or warm up will increase the risk of major leak. For LS2, several leaks will need to be repaired (IT5L, DFBK, A23R8.M ...).

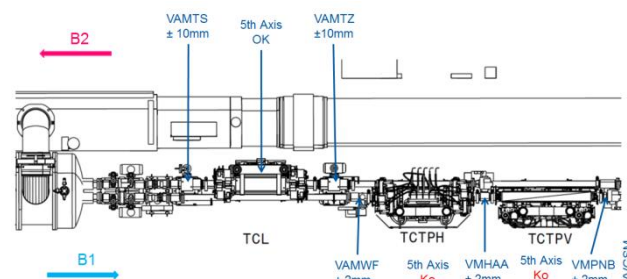
In the current layout, the TCTs are installed between TAN and D2. In these recombination areas, the systems are very tight and the integration is very difficult. This is the case in particular in LSS 1 and 5 where the 5<sup>th</sup> axis is

condemned. As shown in Figure 3, the vacuum system needs to accommodate the presence of sector valves, collimators, mask and BPMs. This can only be done by using connecting module not compatible with the 5<sup>th</sup> axis movement of the TCTPH and TCTPV.

Figure 3: Schematic layout of the TAN-D2 area in C4L5 (courtesy Y. Muttoni EN/MEF).

In order to restore the 5<sup>th</sup> axis functionality, a new layout including new position of TCTs and new interconnecting modules (to be designed and procured) has to be validated.

The implementation of this new layout must take place by YETS 2015, consequently, interventions in vacuum sectors A4L1, A4R1, B4L5, B4R5 must be planned. In the meantime, the collimator system cannot afford the risk to damage the TCTs limiting accordingly the machine operation.

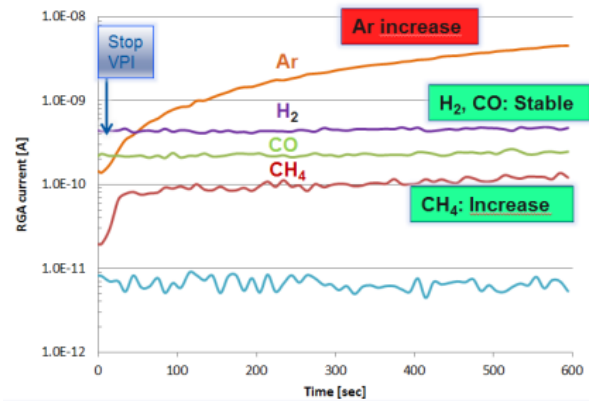
Figure 5 show a typical signature of internal leak. Once external leak have been eliminated, the complementary pumping system is switched off (in this case an ion pump). NEG is then the only remaining pumping system which does not pump noble gas and hydrocarbons. With time accumulation, if an internal leak (composed by air molecules) is present, Ar increase with time. The level of the internal leak can also be estimated from this measurement.

Figure 5: Typical signature of an internal leak (courtesy G. Cattenoz TE/VSC).

Two equipments, installed in the LHC ring during LS1 exhibit large internal leaks level: BQSV.5R4.B1 and TCSP.4L6.B2 with  $5 \cdot 10^{-7}$  and  $6 \cdot 10^{-7}$  mbar.l/s leak rate respectively. If needed, these equipments might be upgraded during LS2.
