## OTHER NON-SOLVED NC ACROSS THE LHC RING AND POTENTIAL IMPACT ON PERFORMANCES

V. Baglin, CERN, Geneva, Switzerland

During Run 1, several non-conformities across the ring with impact on machine performances were identified and planned to be solved during the long shutdown 1 (LS1). During this long shutdown, new non conformities were also produced and / or identified. In this talk, some of these non-conformities are presented and discussed together with their impact on machine operation, technical stops and LS2.

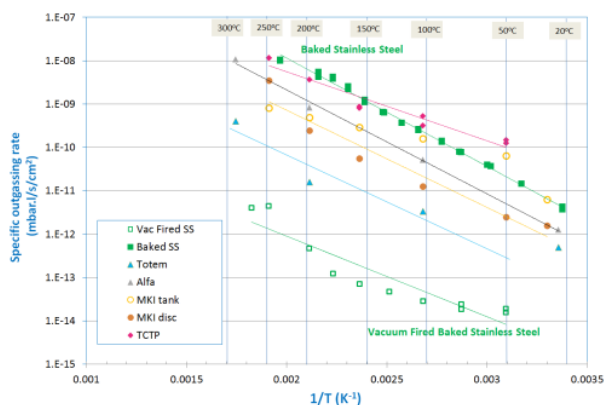
Figure 6: Specific outgassing rate of ferrites compared to baked stainless steel and vacuum fired stainless steel (courtesy G. Cattenoz TE/VSC).

Figure 6 shows the specific outgassing rate of standard ferrites used at CERN and compared to baked stainless steel and vacuum fired stainless steel. These data were obtained followed a degassing treatment of the ferrite at 400 or 1000 °C. The specific outgassing rate is inversely exponentially dependent with the inverse of the temperature.

Therefore, as shown in Table 1, increasing the ferrite temperature from RT to 50 °C will multiply its outgassing rate by 5. Increasing further the temperature, the ferrite outgassing rate can be multiplied by several orders of magnitude increasing significantly locally the vacuum pressure. Long term operation will then saturates the NEG coating and induce radiation to the electronic. Finally, the equipment will need to be repaired during LS2.
